Irish Cove Brook Restoration Project

Irish Cove, NS

2012

Plans, modifications and results

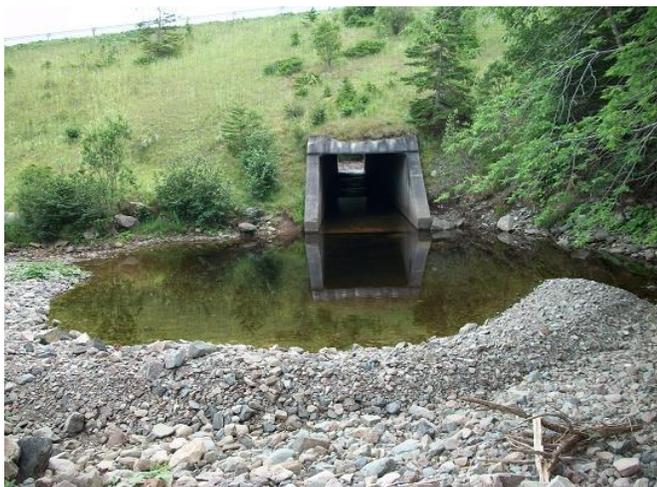
The upper section has a culvert plunge pool 19m long that has been formed by scouring during high flows. This has deposited gravel and cobble in the stream channel, completely blocking a 117m section of the channel except during very high freshets. The normal flows now leave the plunge pool through a scoured out channel on the right bank, along the toe of the highway fill, lowering the water level in the pool creating fish passage problems in the culvert. Sixty meters downstream this channel rejoins the original channel in a phase shifted meander pattern. There is a small amount of seepage under the infilled channel. Both channels flowed during high flow events in the fall of 2010 and 2011.

Fig 2 A large 19m diameter pool has been scoured at the outlet of the Highway #4 culvert

In 2011 the remaining 689m of the Brook was SandWand and the original plunge pool channel was reconstructed to bring it in line with DFO guidelines for the design of plunge pools and to raise the water level 60cm to back flood the culvert to provide fish passage. This channel is 117m long @6.5m wide for new habitat of 760 sqm. The upper end of the channel remained closed so that it could stabilize and just be subject to flood flows.

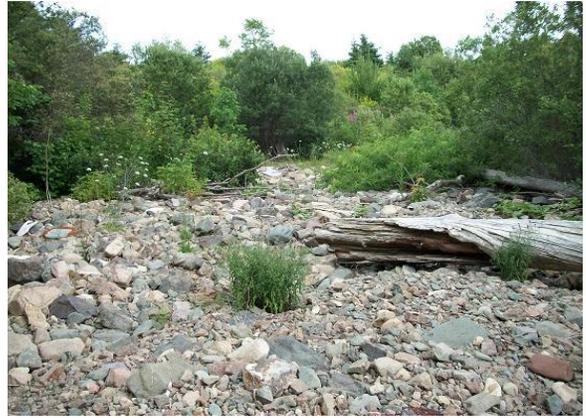
Fig 3 With the original channel blocked the flows are directed right down a 60m back channel

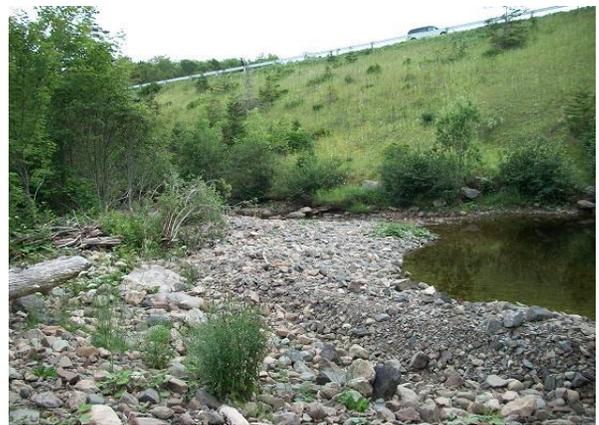
Fig 4 Material scoured out of the plunge pool had been deposited in the channel, blocking water flow

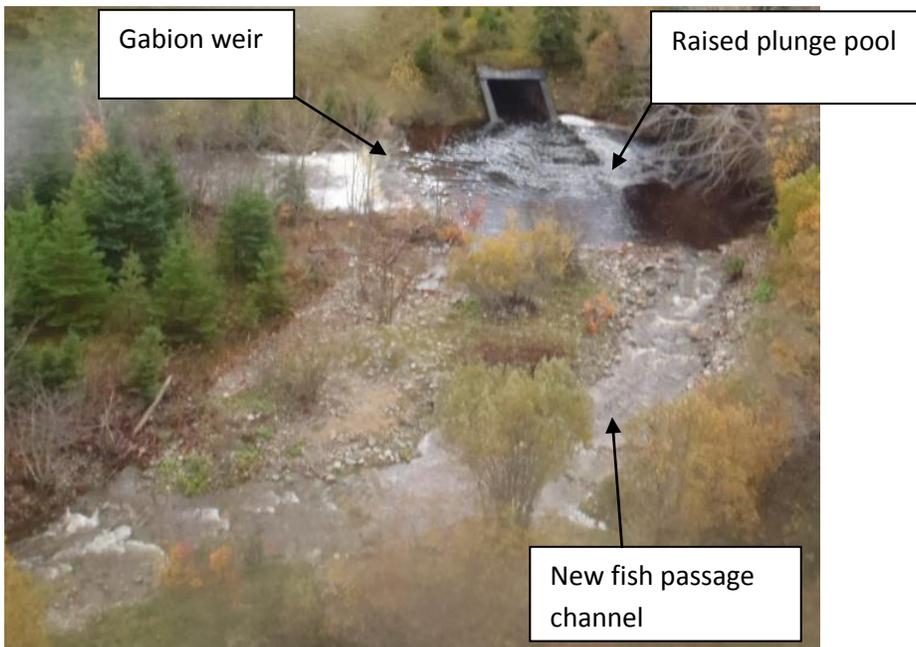
Fig 5 November 2012 photo of culvert pool and new channel under Fall flows.

In 2012 the channel was repaired in a couple places and the top end opened to carry the base flows. To preserve habitat in the channel along the toe of the slope a double gabion weir was built across the channel at the edge of the pool. It was set so that a maintenance flow would remain in the channel and it would act as a flood channel while raising the pond by 60 cm resulting in no loss of habitat at the site due to the diversion as requested by DFO. Fig 5.

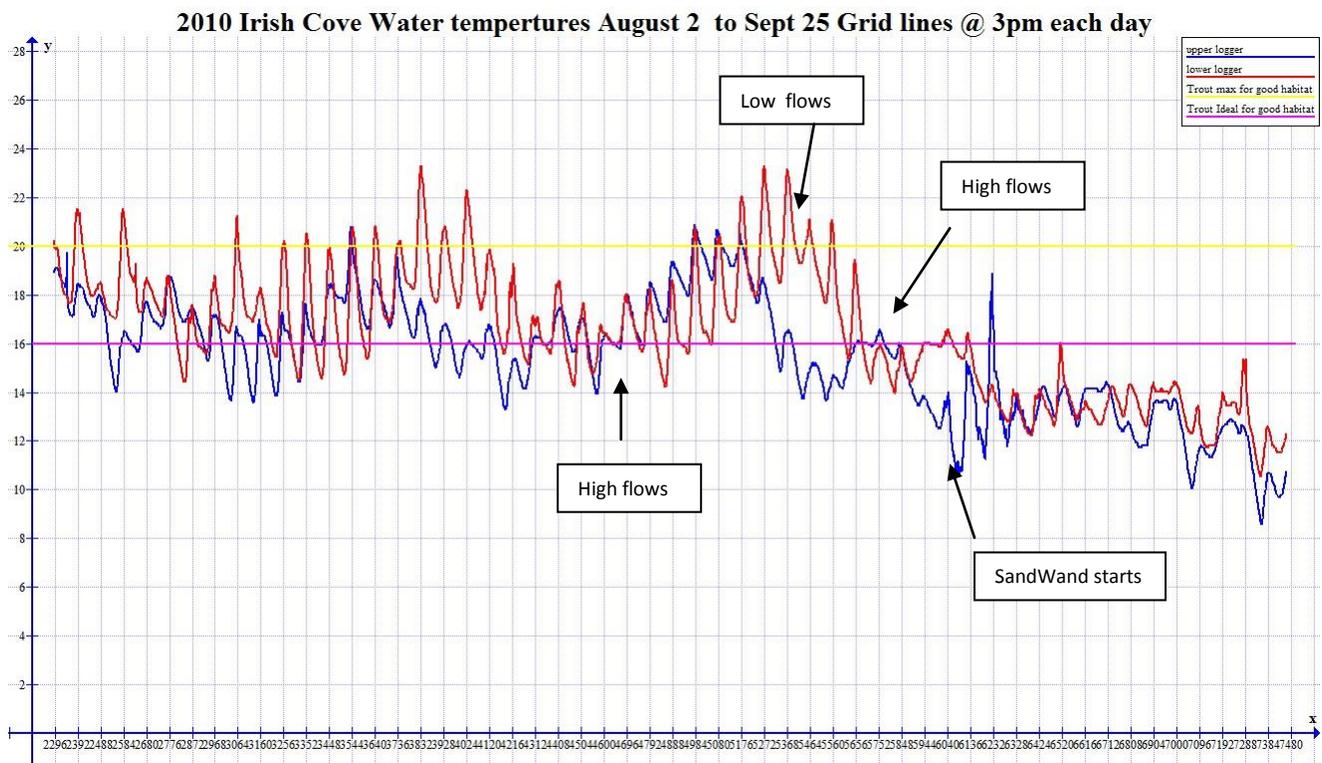
Fig 6 2010 Temperature Monitoring Results

Thermographs in the Brook in 2010 (fig 2) showed more detailed results. Water temperature at the Highway culvert pool was good throughout the late summer. Water temperatures below the over widened section fluctuated more widely and were often above Trout tolerance levels. It appears as though the temperature variation and increase disappeared as the SandWand work progressed but there are other possible explanations that might give this result including dropping air temperatures.

The 2010 upper and lower water temperatures are shown in Fig 2. Water temperature is affected by flow levels, air temperature, and stream pool/riffle/thalweg structure, and shade. The data indicated that the water temperature at the mouth of the brook followed or exceeded shade air temperature. It can be seen here that at times of low flows the daily low temperature below the degraded habitat was still higher than the daily high of the water entering the site. Also the daily fluctuation was greater at the lower site. This is due to the shallow flow between rocks in the over widened section and the lack of inter-gravel flow due to the embededness of the substrate in sand and silt. We were encouraged by the observation that water temperature at the lower site more closely followed the pattern of the upper site even with a short section SandWanded. This is likely due to increased ground water interchange and the increased thermal mass provided by the water flowing through the clean gravel. However there are other explanations for this as the weather did cool.

Blue (Series 1) is the upstream thermograph just below the culvert pool.

Red (Series 2) is the downstream thermograph just upstream of the ford and just above the end of the SandWand work for 2010.

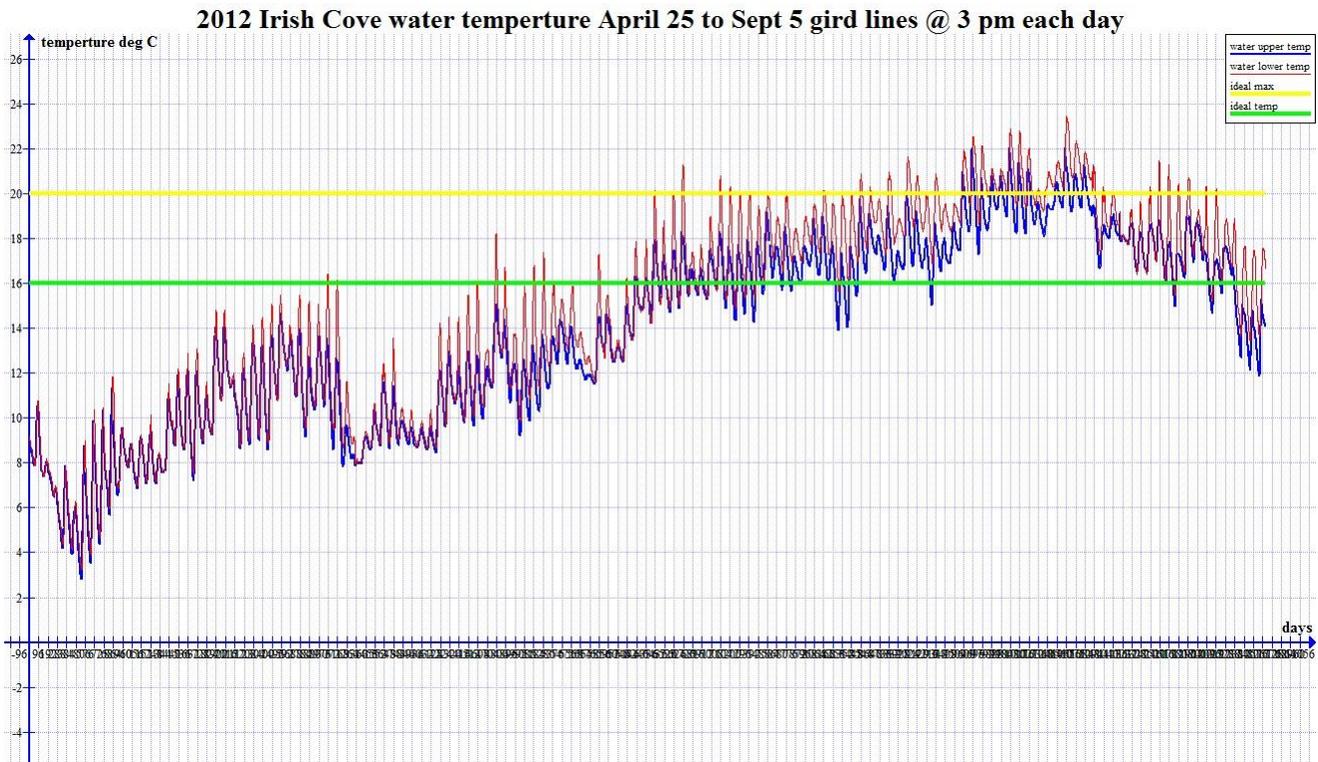
In 2012 (Fig 3) both temperatures followed the same pattern which was an improvement but the lower water temperatures still have a greater fluctuation and maximums are now peaking at 2 to 3 degrees higher. This is especially true during the low flow periods.

The green line is the ideal growing temperature for Brook Trout that we would like to average throughout the growing season 16 °C. The yellow line is the maximum temperature we would like to stay below for Trout 20 °C.

Fig 7 2012 Temperature Monitoring Results Blue (Series 1) is the upstream thermograph just below the culvert pool. Red (Series 2) is the downstream thermograph

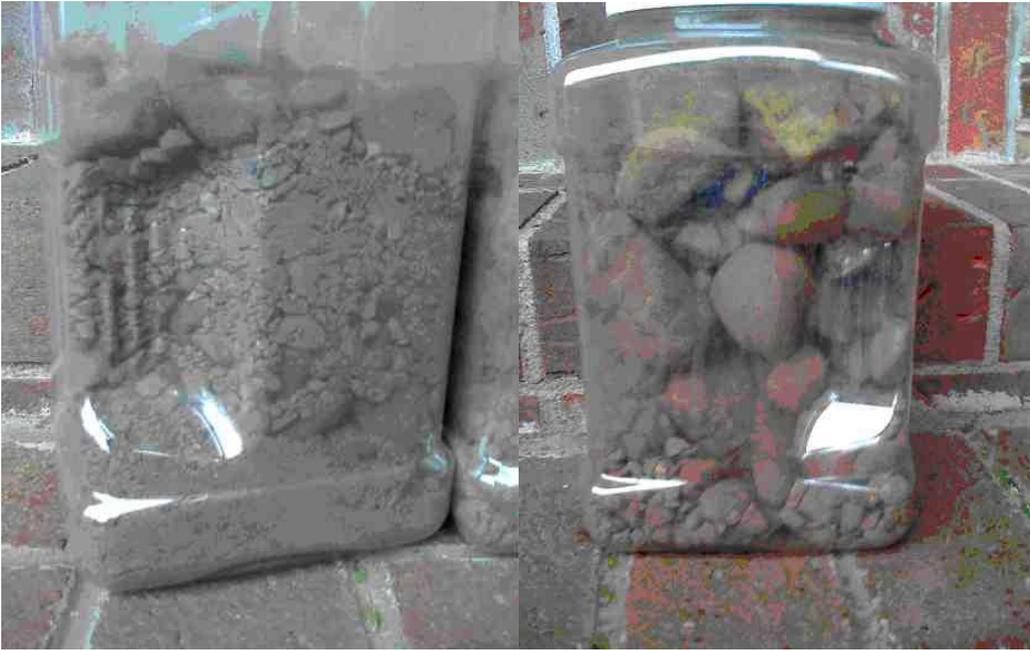
Core samples were taken by working a steel pipe into the substrate at least 25cm and removing the contents by hand. Fig 4 below shows the before sample with sand and silt and the after sample of cleaned gravel. It is clear to see that the intestinal spaces have been cleared and the substrate un-grouted making it 5 to 10 times more mobile and able to be shaped by the stream flows into a more productive pool/ riffle/thalweg stream structure.

Fig 8 Gravel samples before cleaning and after

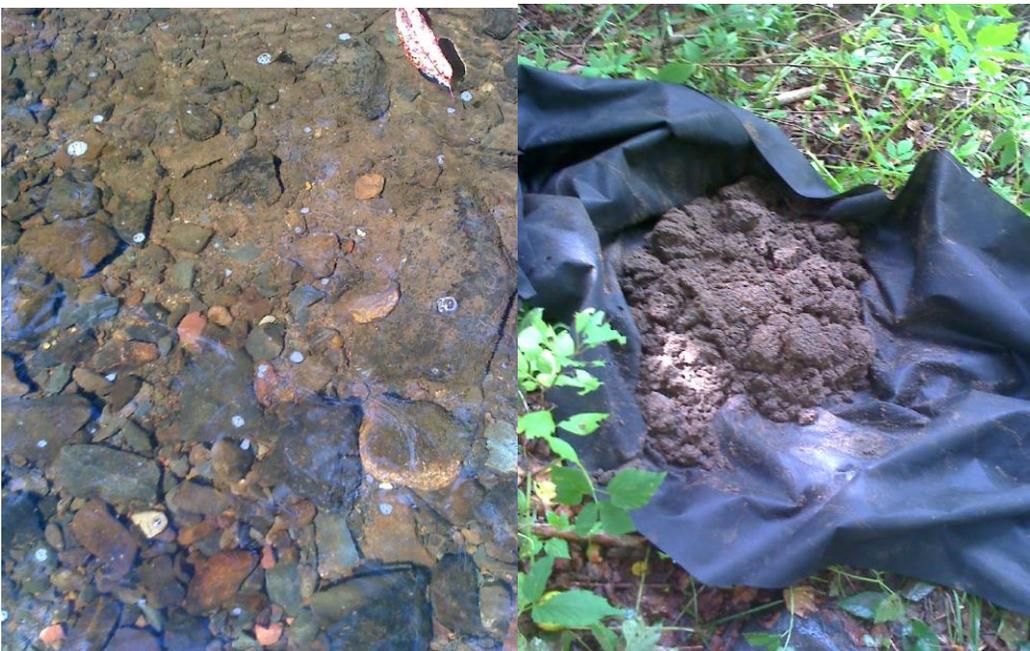
In fig 8 the right hand picture shows the surface view of the substrate with un-cleaned gravels at the top and cleaned bottom and the picture on the left shows the nature of the sand removed. It is very similar to beach sand. The silt content is very low with the discharge water staying under 80 mg/l and it is almost not measurable in the sample analysis.

Fig 9 The output is clean “beach sand” with suspended solids < 80 mg/l

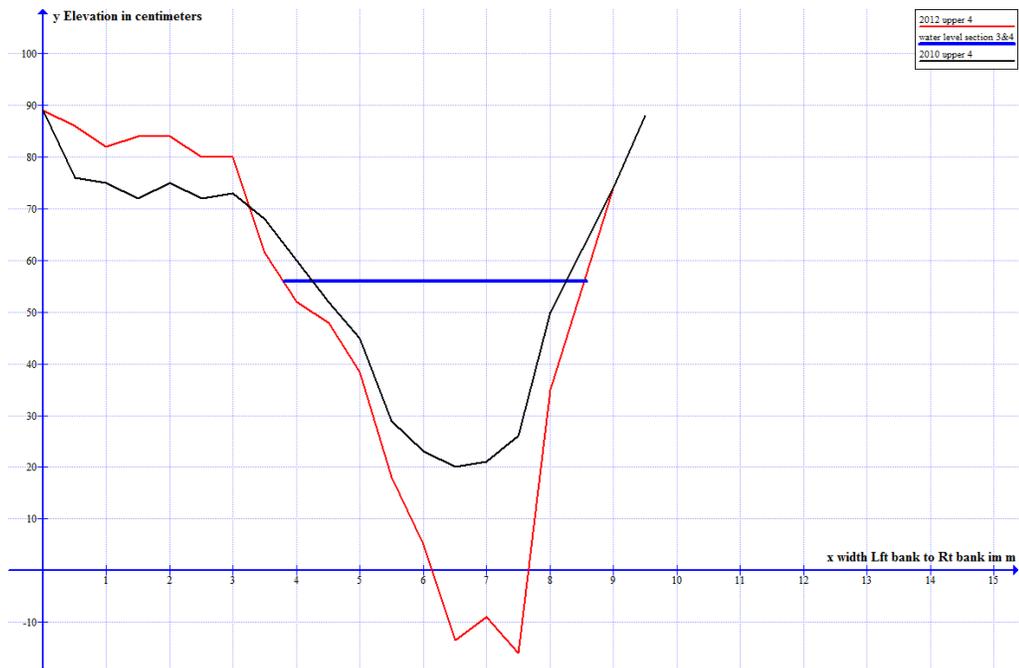
Fig 11 Pool cross sections

Figure 11 is the cross section in the pool area of the 2010 study site. The black line is the 2010 cross section and the red line is the 2012 cross section. The point bar has risen by approx. 10 cm and the pool has widened slightly but deepened by 30 cm resulting the exposure of several boulders that provide cover for larger age classes of trout. The blue line is the normal summer water level.

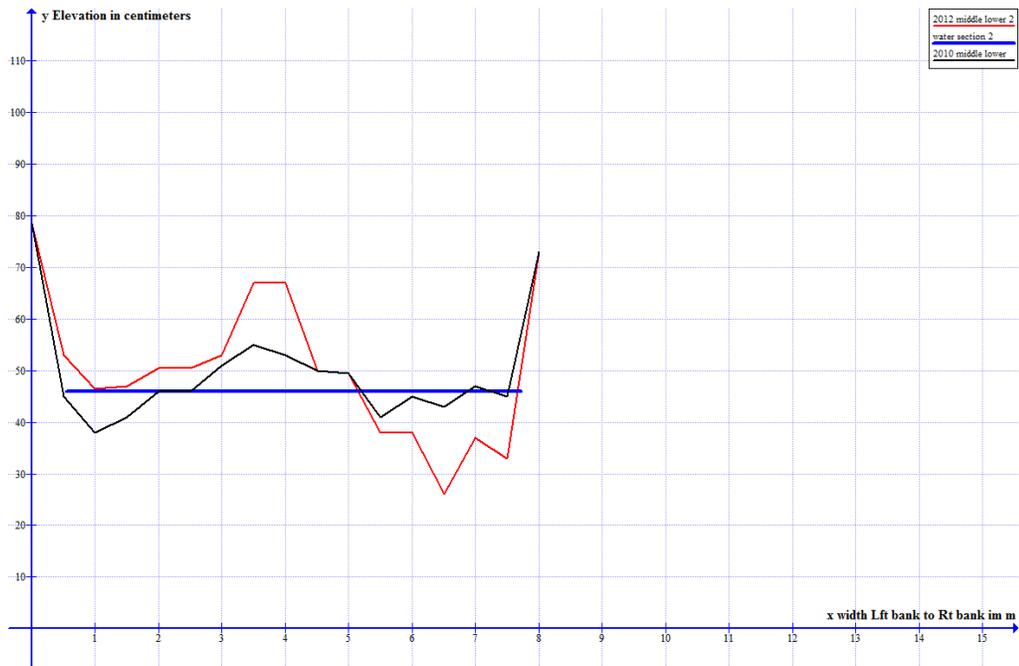
Fig 12 riffle cross sections

Figure 12 is the cross sections across the riffle area. The split channel is starting to fill in and the bar is building while the thalweg has deepened approximately 15 cm providing a single deeper riffle that was used by the young of the year trout.

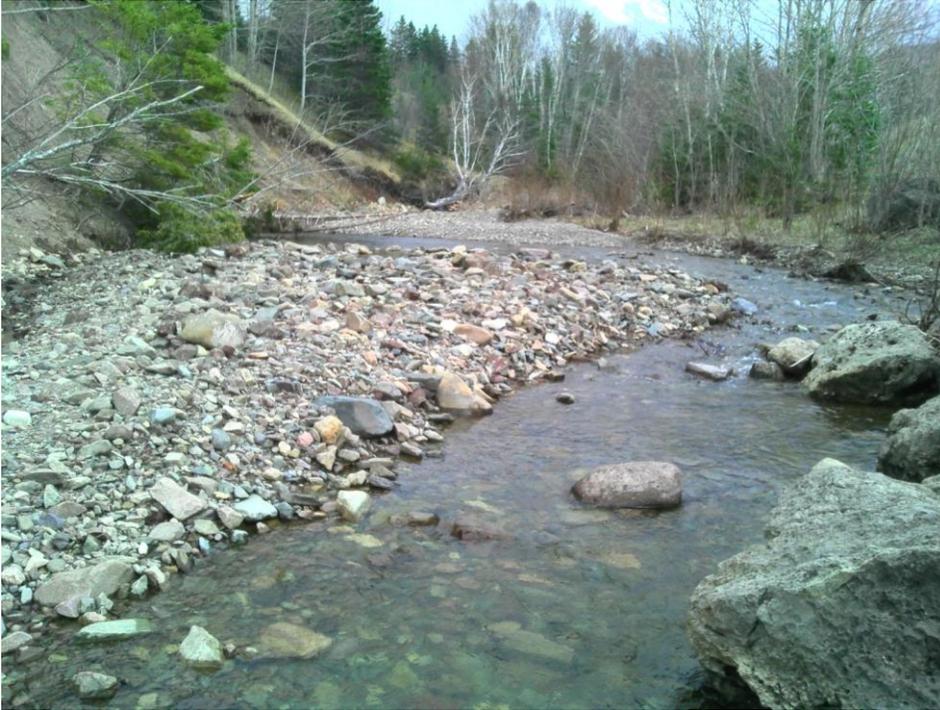
Generally the over widened sections have narrowed up and formed a meander pattern with pools on the bends. The un-grouted the stream gravels allows the formation of proper stream structure. In fig 13 the meander pattern has developed taken the flow way for the toe of the eroding bank. In 2011 the main channel was along the toe but the entire width had water flowing between the rocks.

Fig 13 new meander pattern at low flow

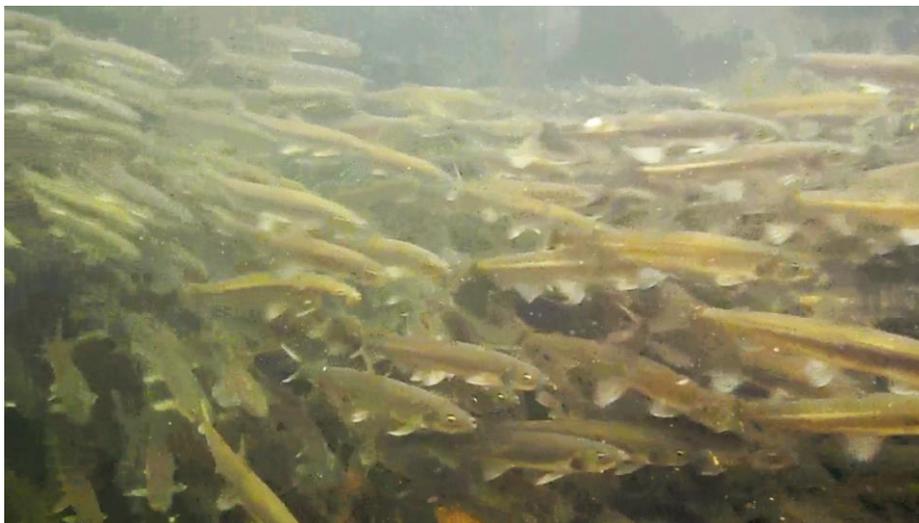
Smelt we present in large numbers to the upper end of the SandWand work and not beyond. In 2011 they appeared to reach just the lower test site. In 2012 after the whole site had been SandWanded the smelt filled the pool up to the top of the site but not into the culvert pool. Figure 14 shows the concentration of smelt 2/3 of the way up the restored section. If the smelt can migrate up this far so can all the other resident fish so we have greatly improved migration habitat that was restricted by long shallow runs and the lack of resting pools.

Fig 14 Smelt in a upper pool
